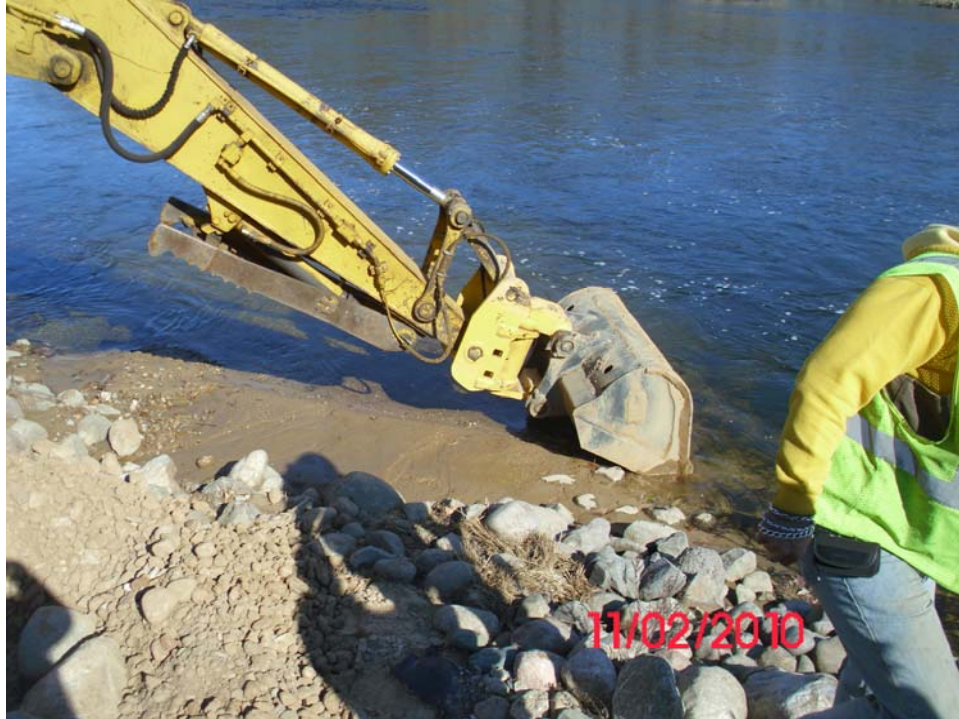
Photo 1: View of wash-out into Kalamazoo River at beginning of removal, facing northeast

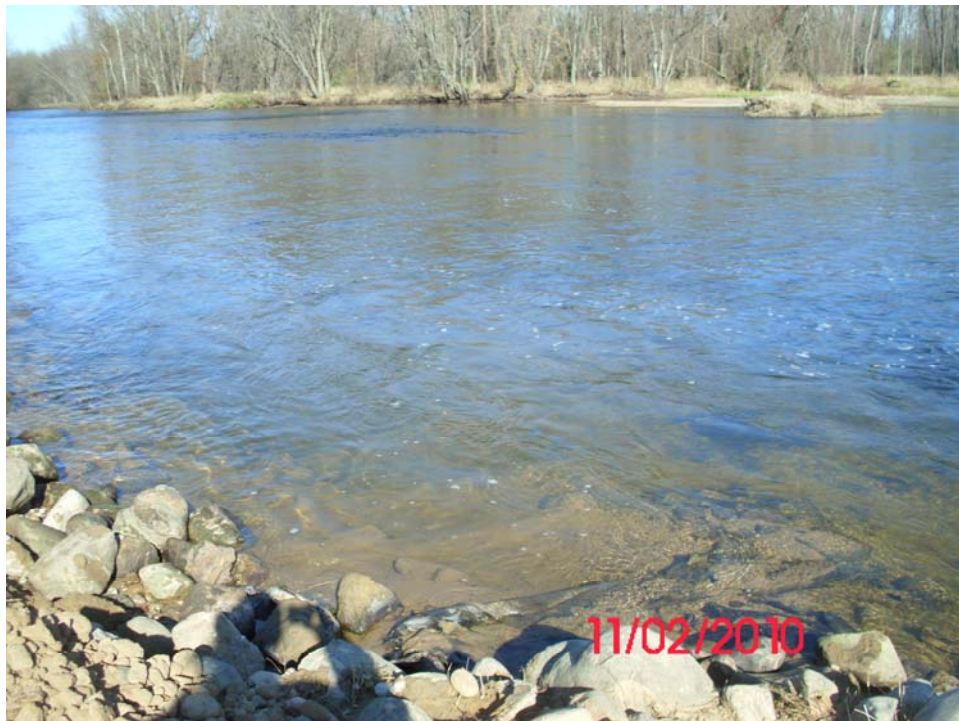
Photo 2: View of Kalamazoo River after removing general fill material, facing northeast

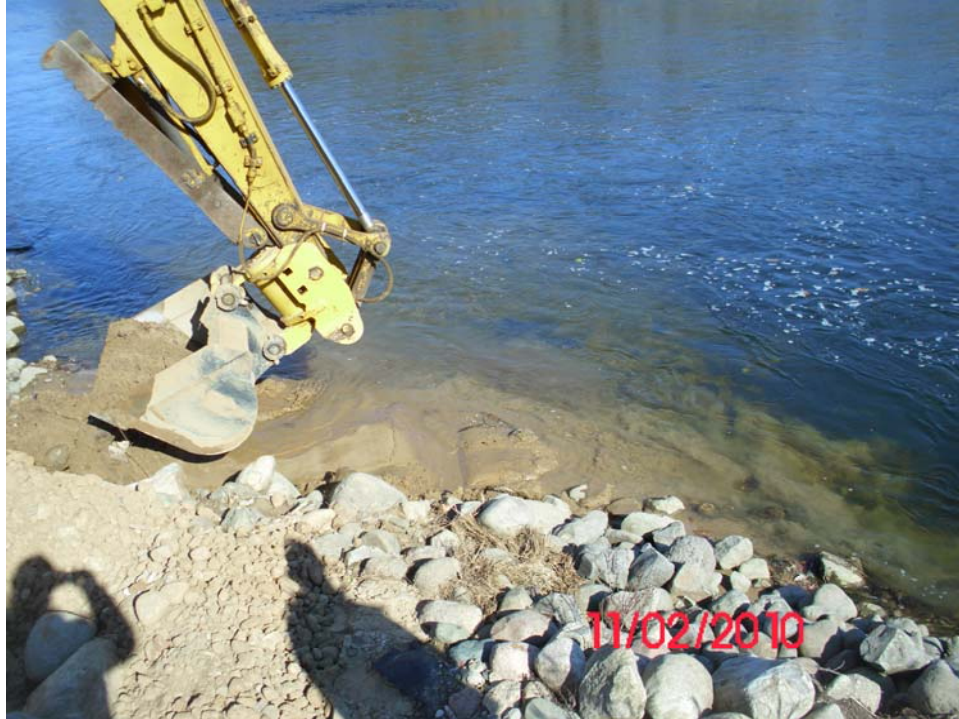
Photo 3: First bucket of material removed, facing northeast

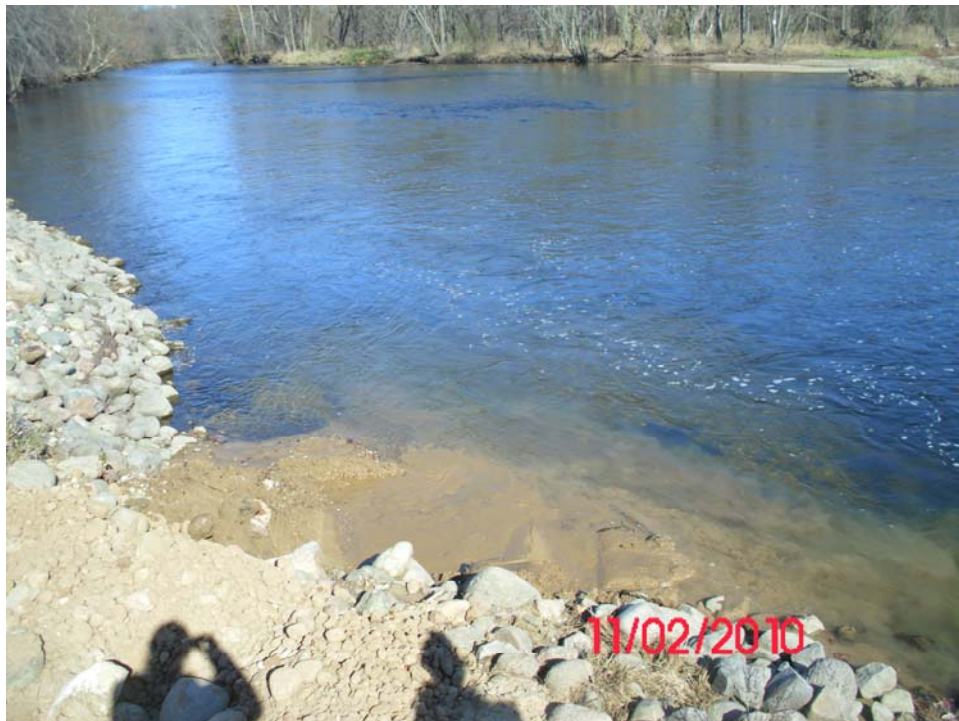
Photo 4: View of removal area after first bucket, facing northeast

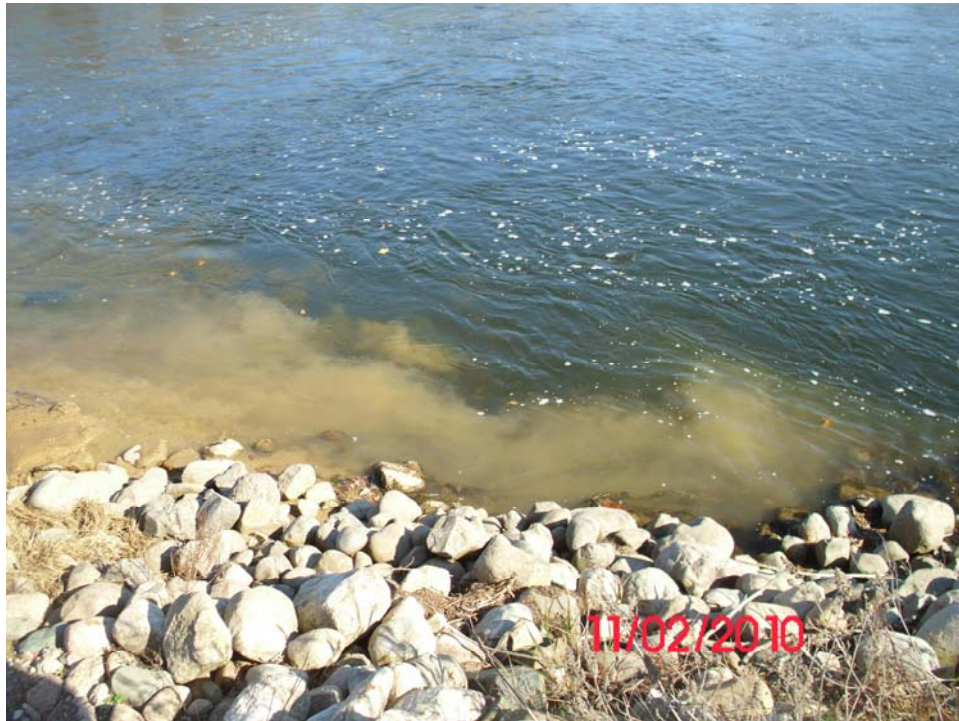
Photo 5: Turbid condition slightly upstream of removal area, facing east

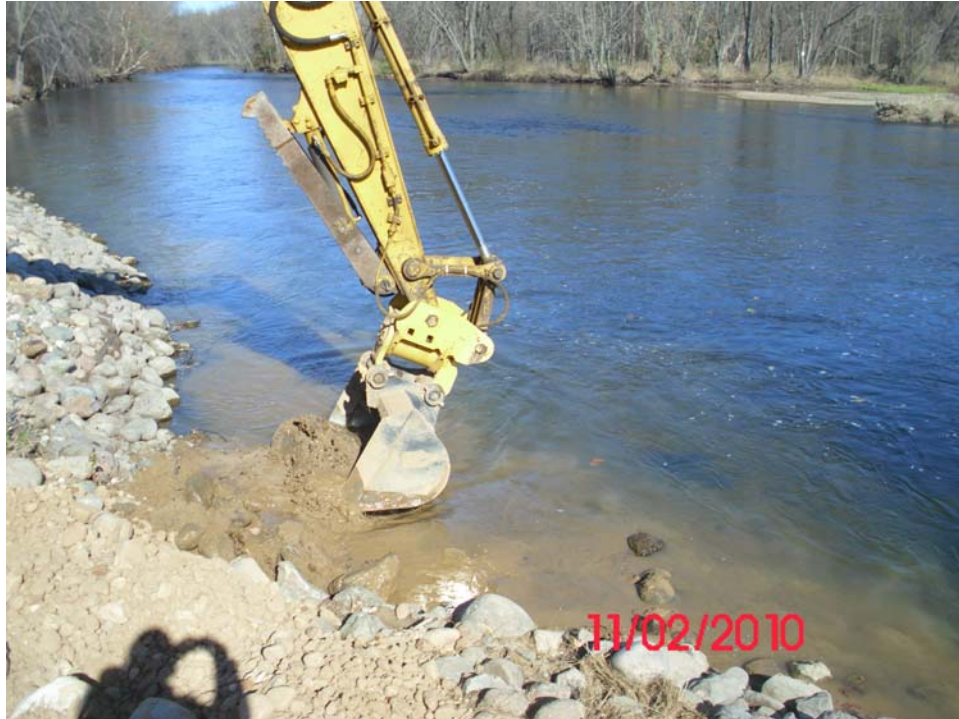
Photo 6: Another bucket of material removed, facing northeast

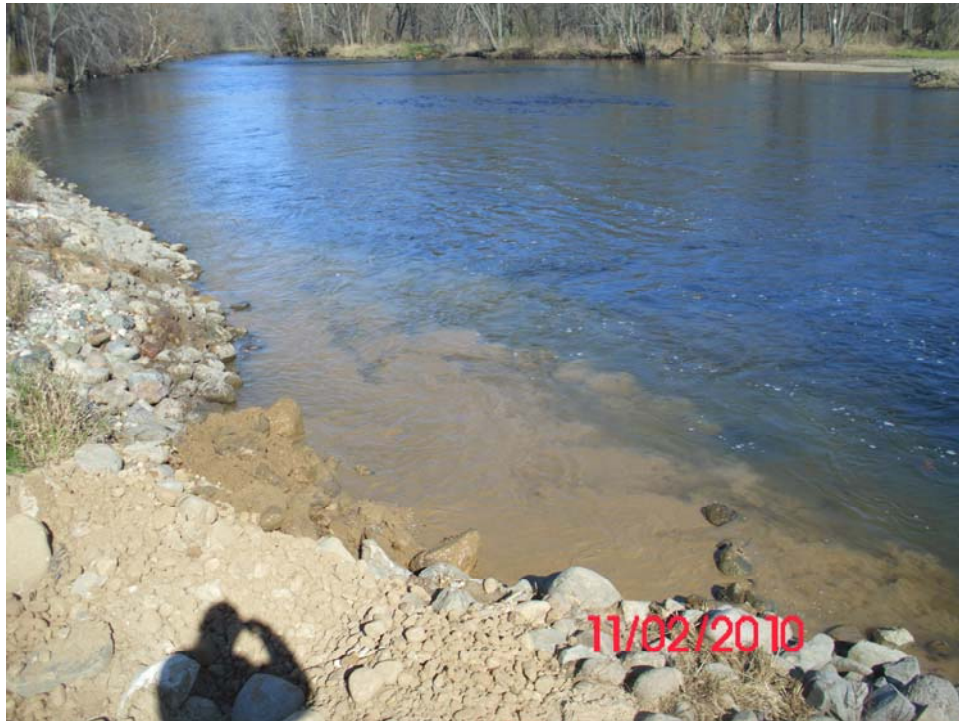
Photo 7: View of removal area after additional bucket of material removed, facing northeast

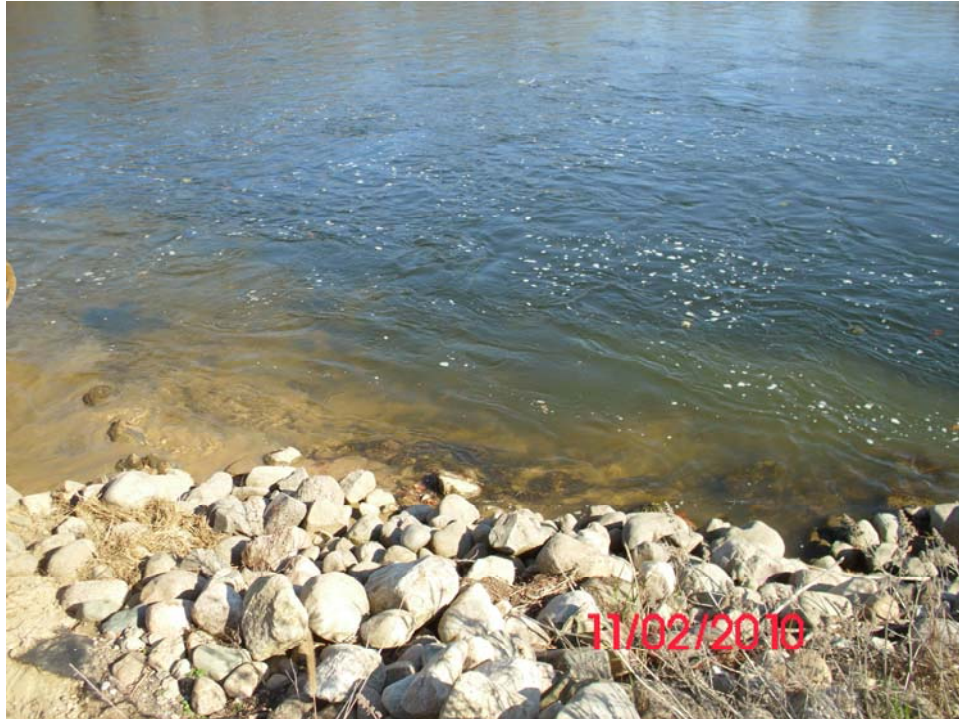
Photo 8: View of upstream location clearing after approximately 4 minutes, facing east

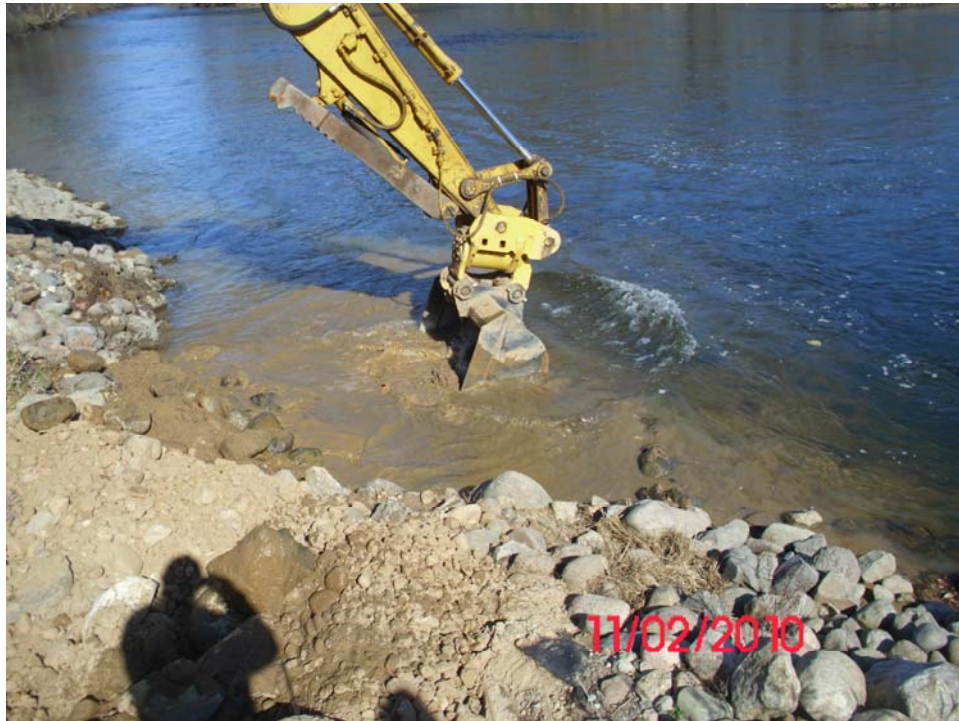
Photo 9: Additional removal of material, facing northeast

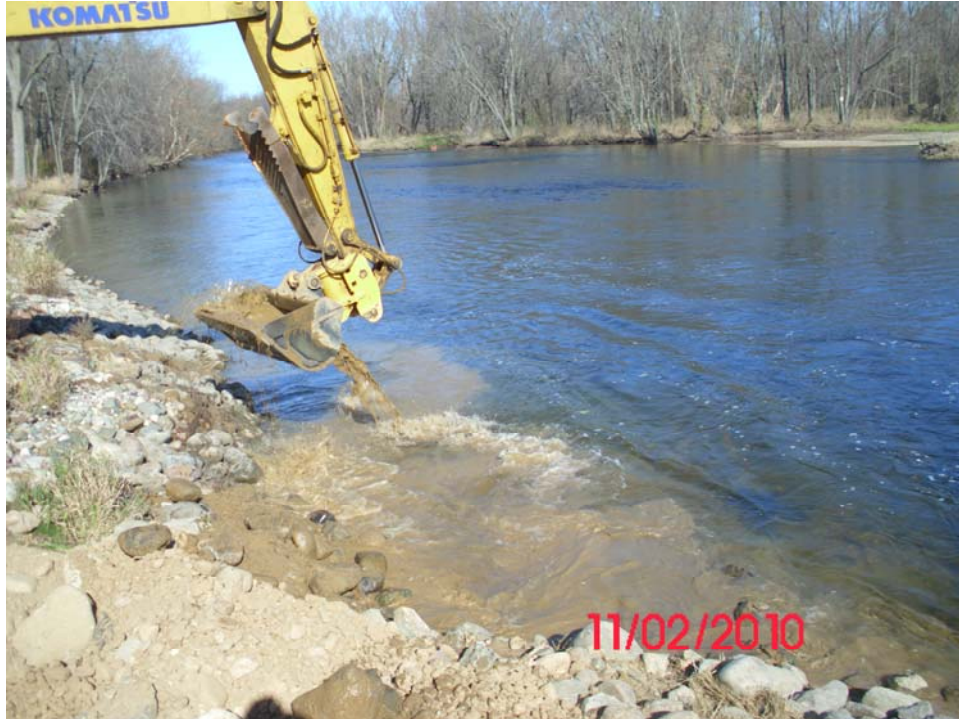
Photo 10: Another view of removal of material, facing northeast

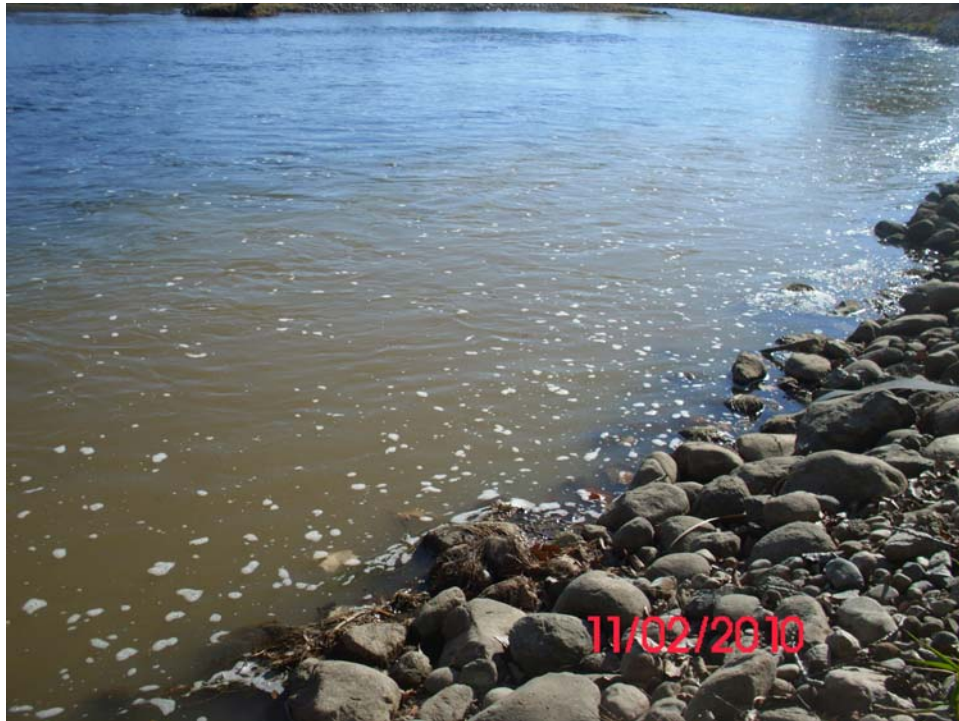
Photo 11: View of turbid conditions downstream (~275 feet away from removal area), facing southeast

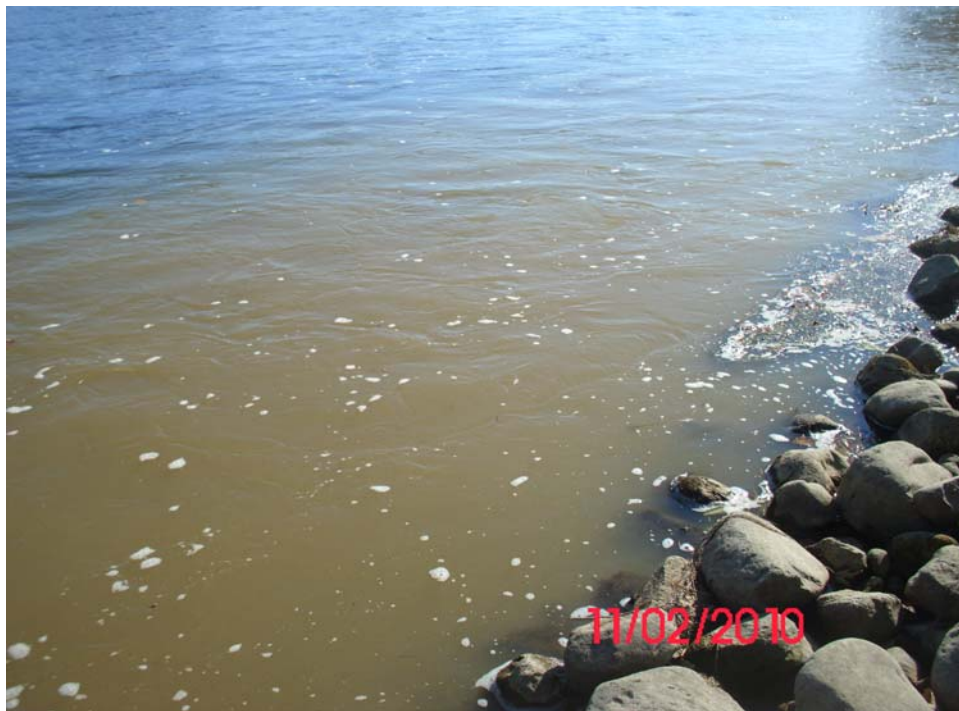
Photo 12: Close-up of turbid conditions downstream, facing southeast

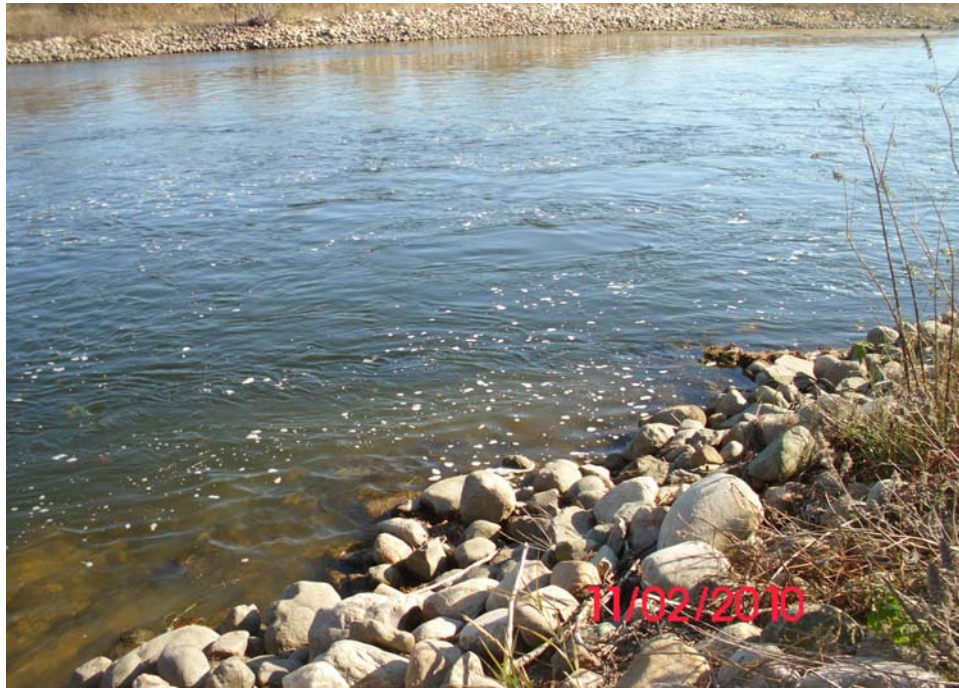
Photo 13: View of river near removal area approximately 8 minutes after a stop in removal activities, facing southeast

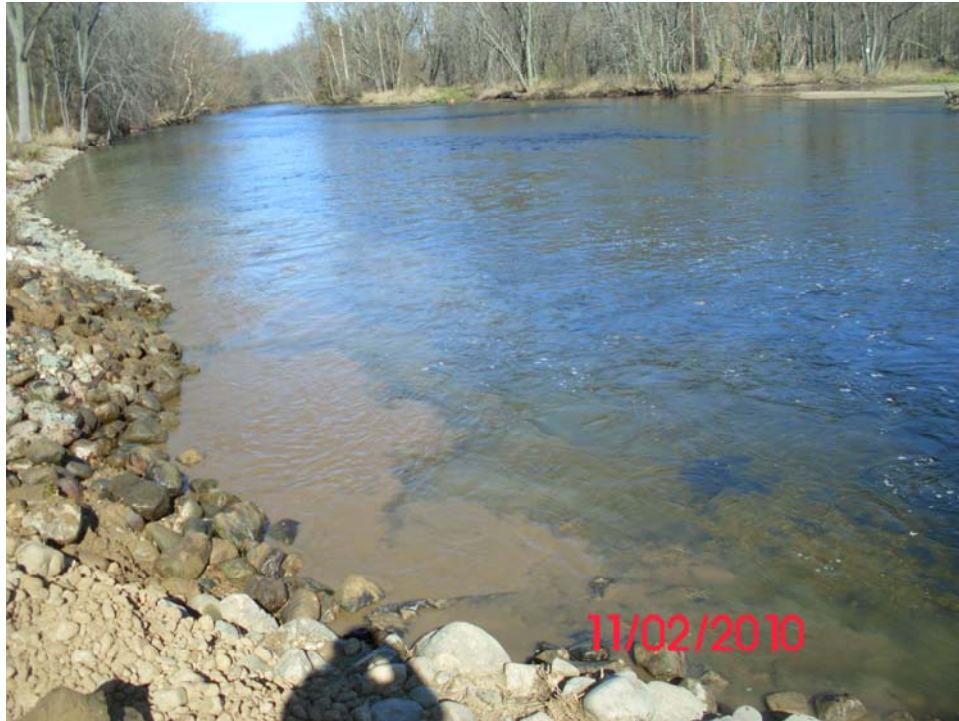
Photo 14: Additional removal of material, facing northeast

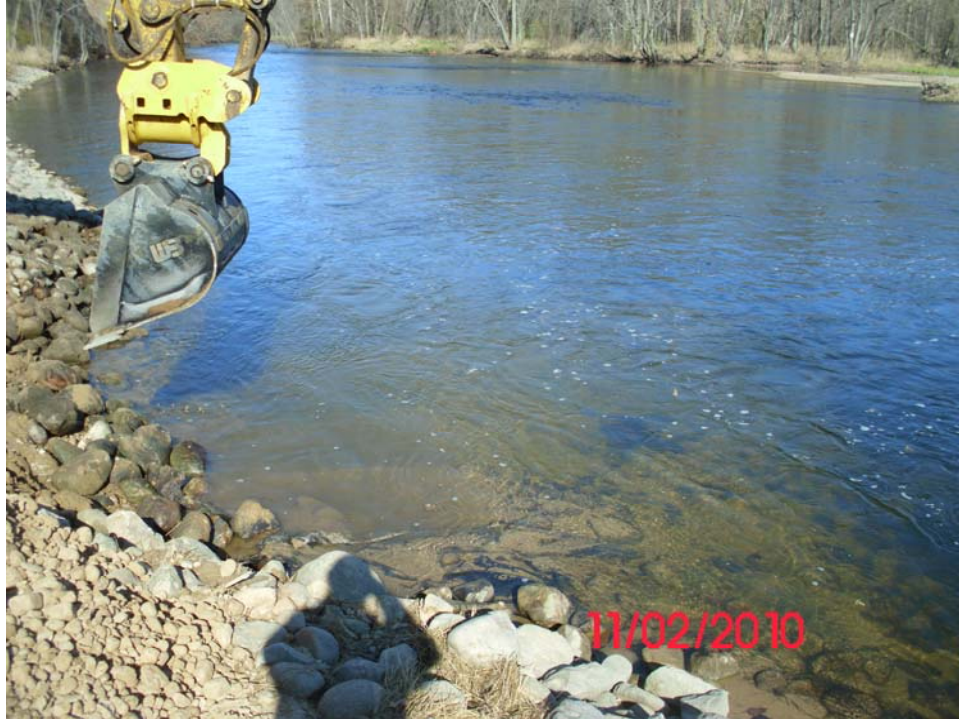
Photo 15: View of removal area approximately 9 minutes after a stop in removal activities, facing northeast

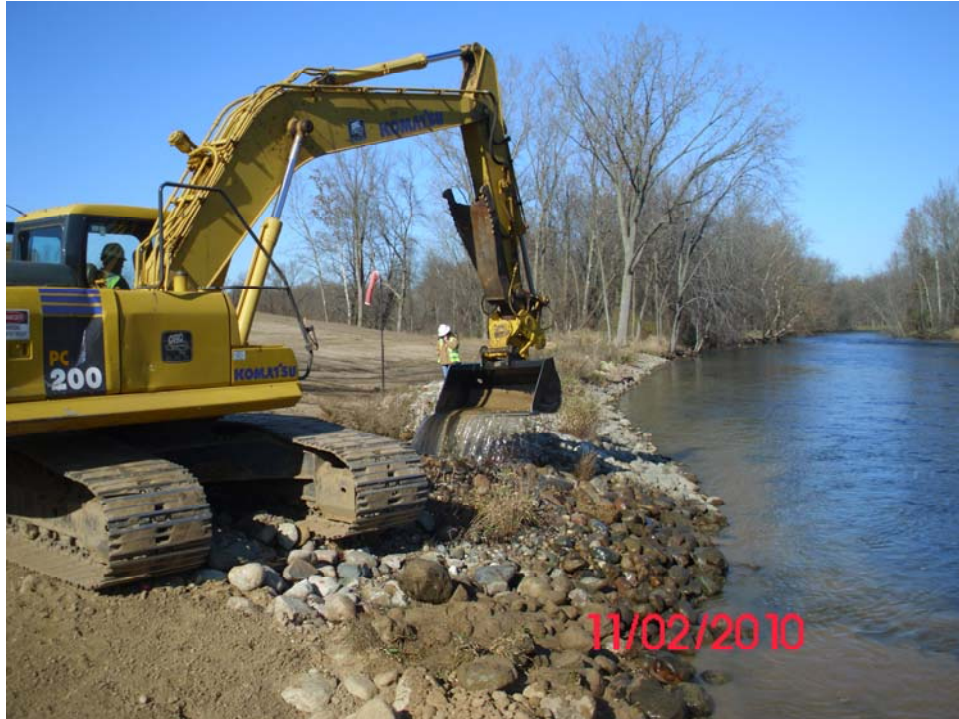
Photo 16: View of additional removal of material, facing north

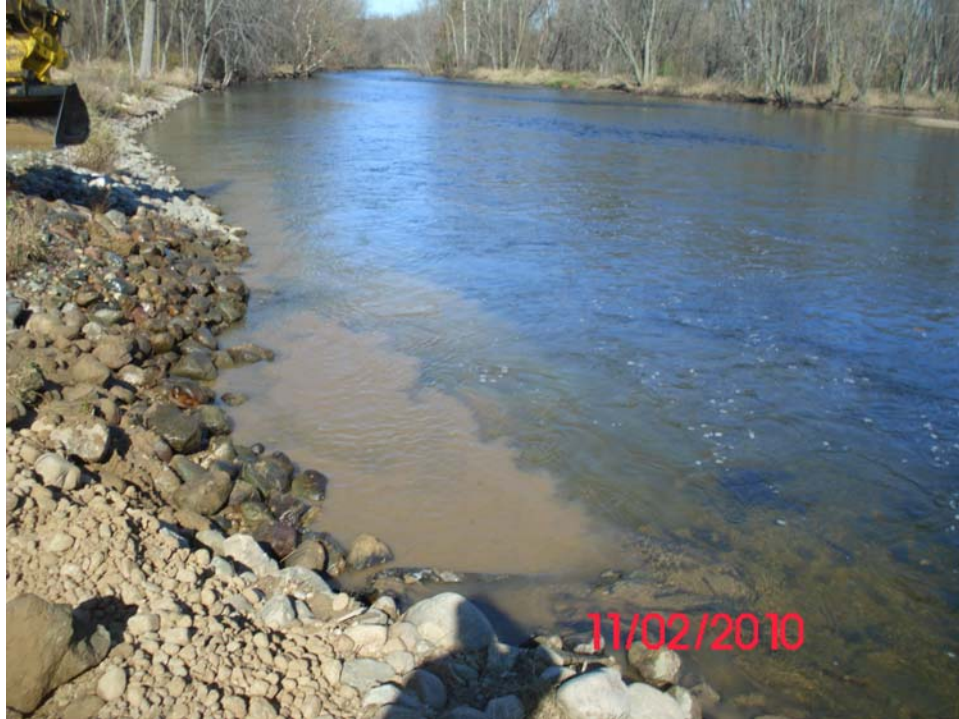
Photo 17: Close-up of removal area after removal of additional material, facing north

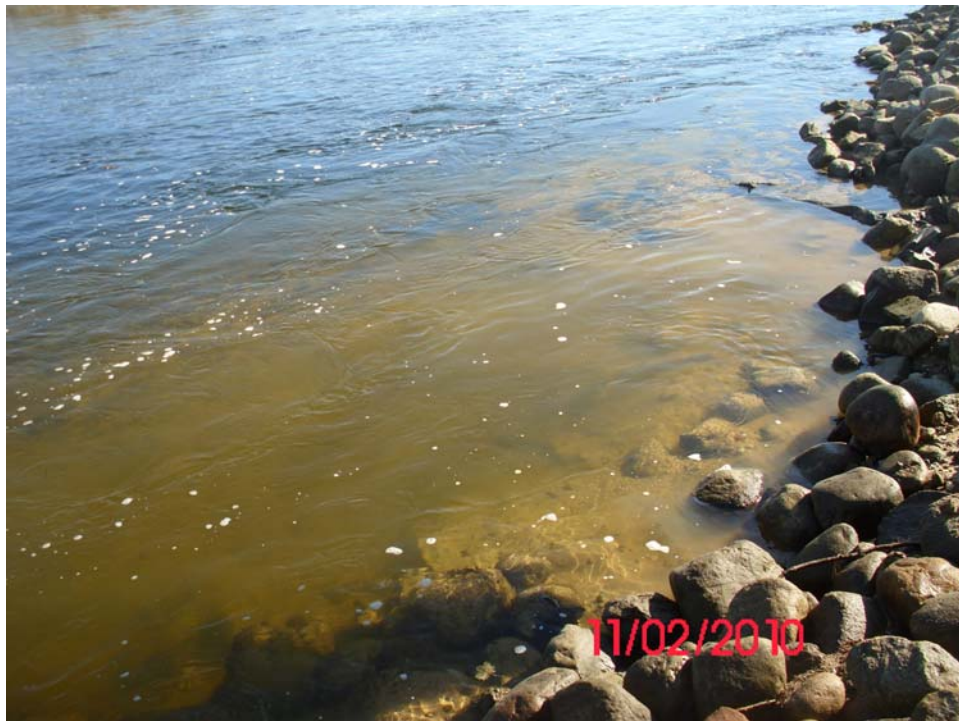
Photo 18: Close-up of removal area approximately 14 minutes after removal of material, facing southeast

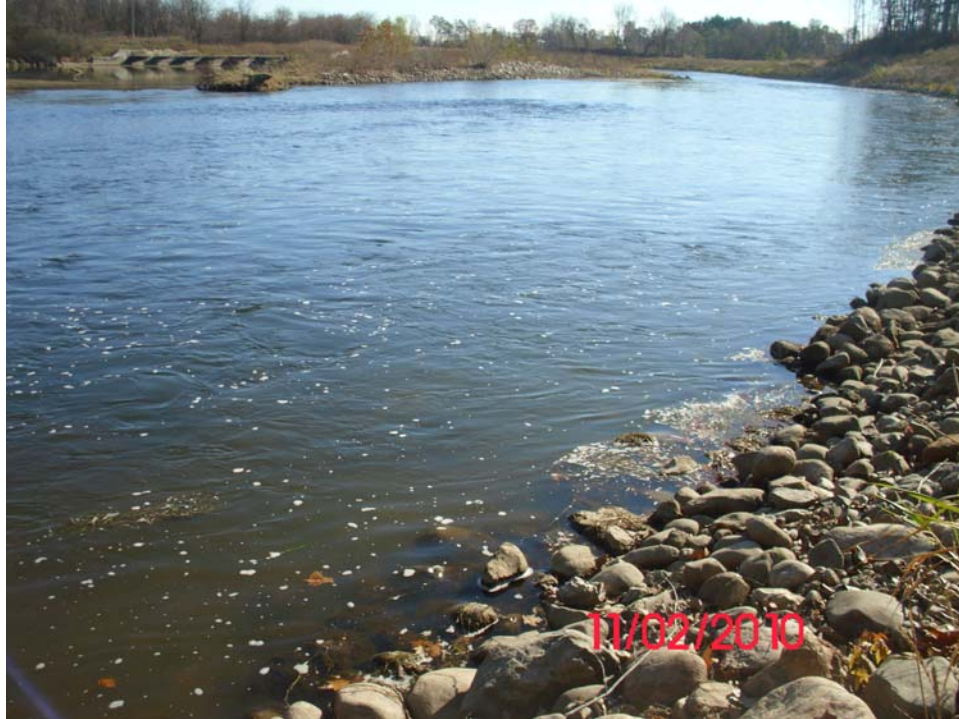
Photo 18: View of downstream location approximately 16 minutes after stopping removal activities, facing southeast

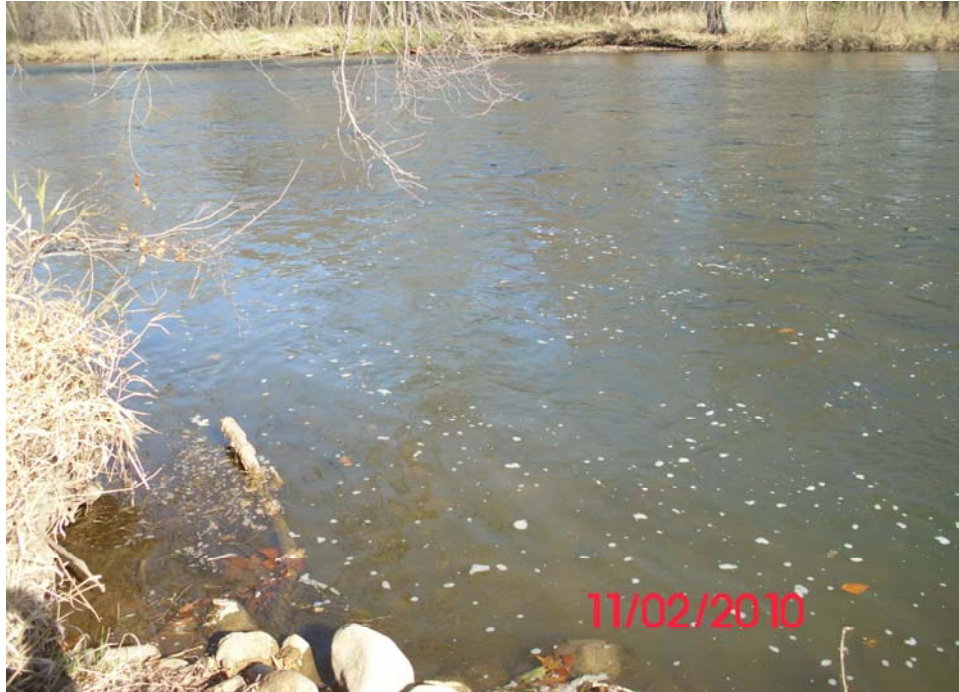
Photo 19: View of downstream location approximately 16 minutes after stopping removal activities, facing northeast

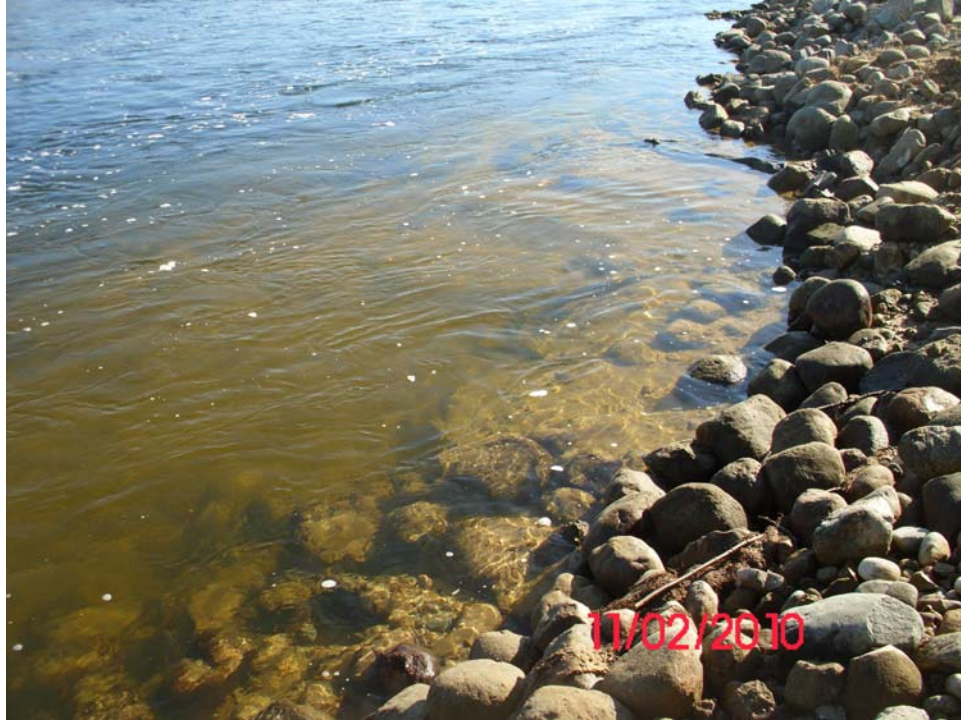
Photo 20: View of removal area approximately 19 minutes after stopping removal activities, facing southeast

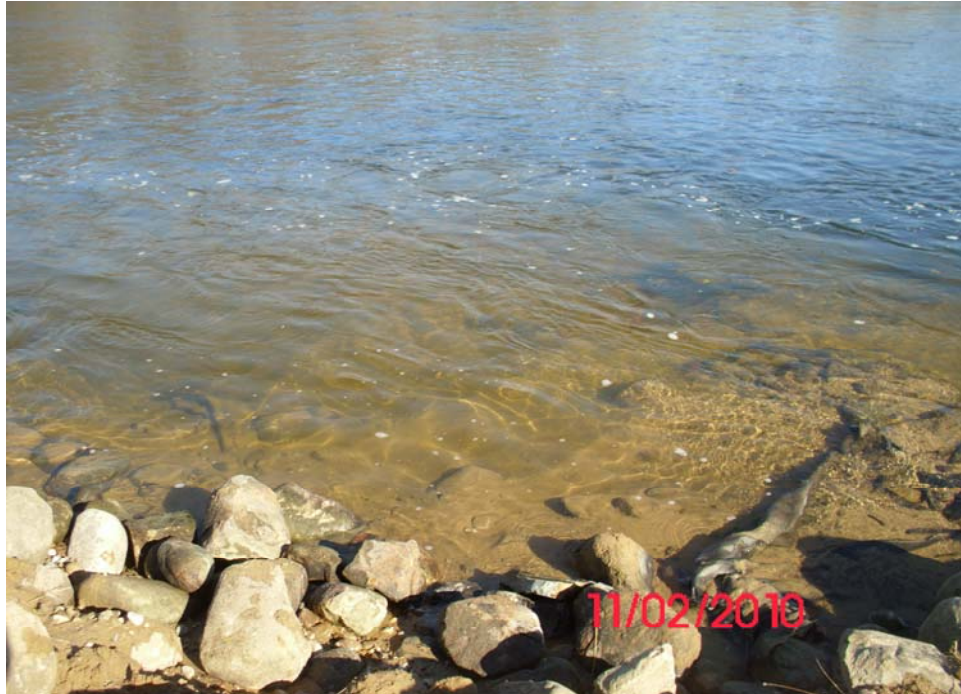
Photo 21: Another view of removal area approximately 19 minutes after stopping removal activities, facing east

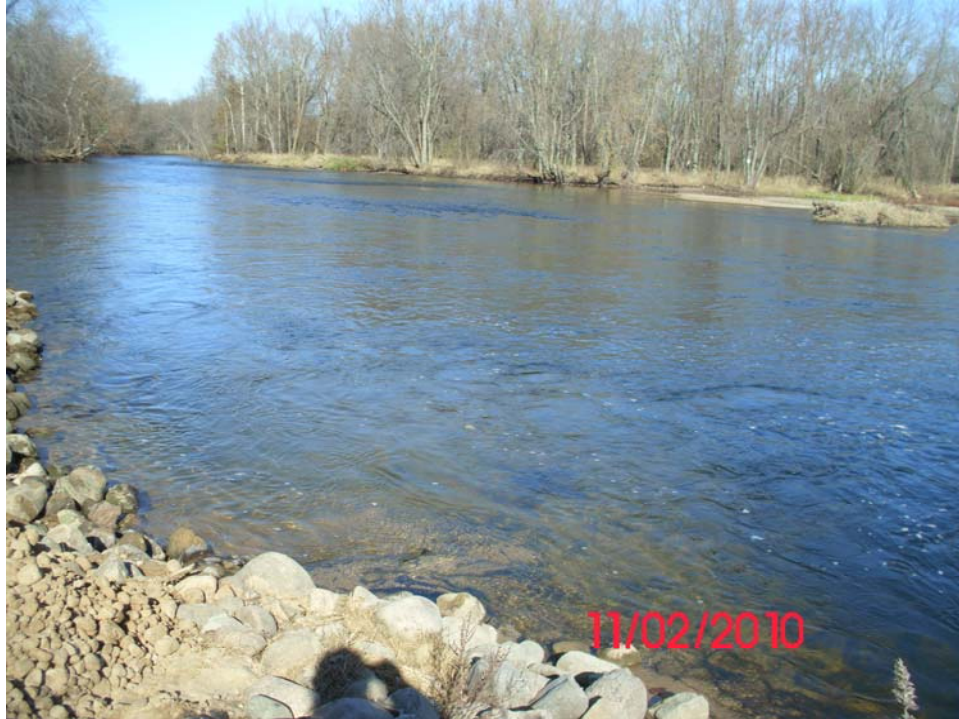
Photo 22: Another view of removal area approximately 24 minutes after stopping removal activities, facing northeast

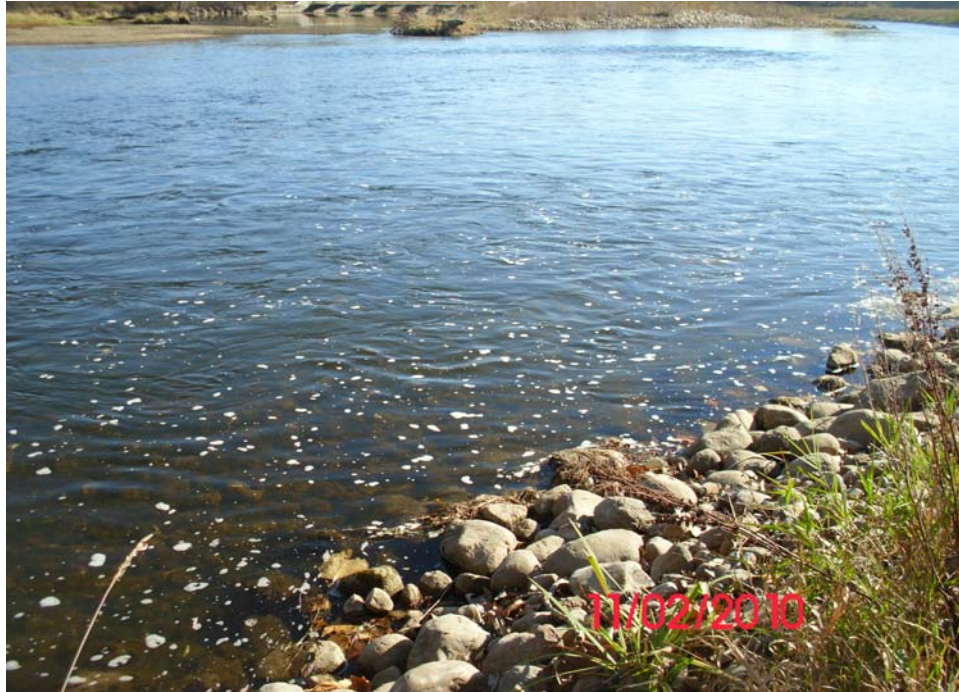
Photo 24: View of downstream location approximately 37 minutes after stopping removal activities, facing southeast
